T-55 Engine Compressor Stator Vane Investigation

ARL-TR-2123

November 1999

Weapons and Materials Research Directorate, ARL

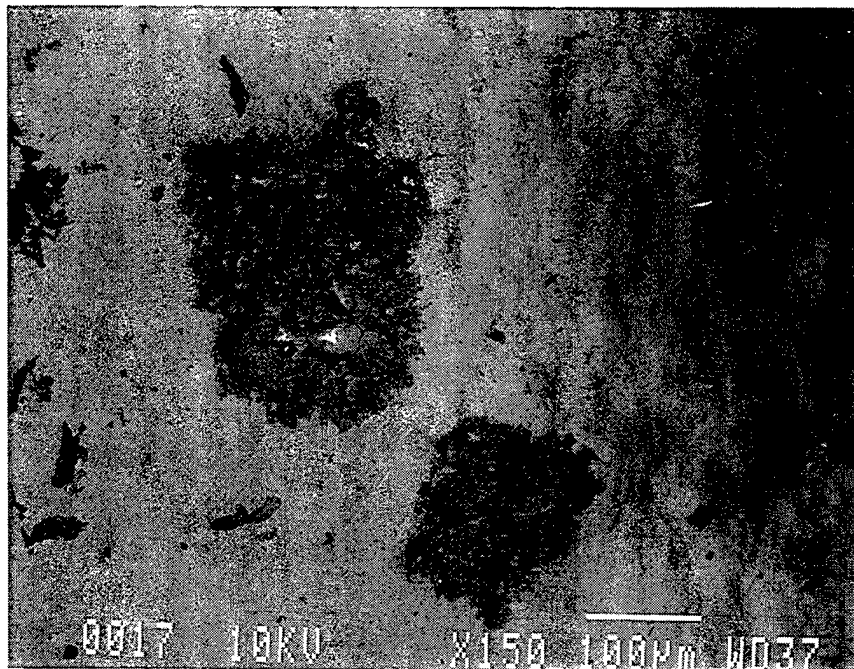
dark areas of corrosion were verified to be pits containing a significant amount of corrosion product. A cadmium plating was detectable on all surfaces; however, in some instances, base metal elements were also detectable, indicating a thin or discontinuous coating. Figures 15 and 16 show the corrosion product within the pits in both secondary and backscatter electron imaging, respectively.

Figure 16. Backscatter Electron Image of the Product Within a Pit (Magnified 150×).

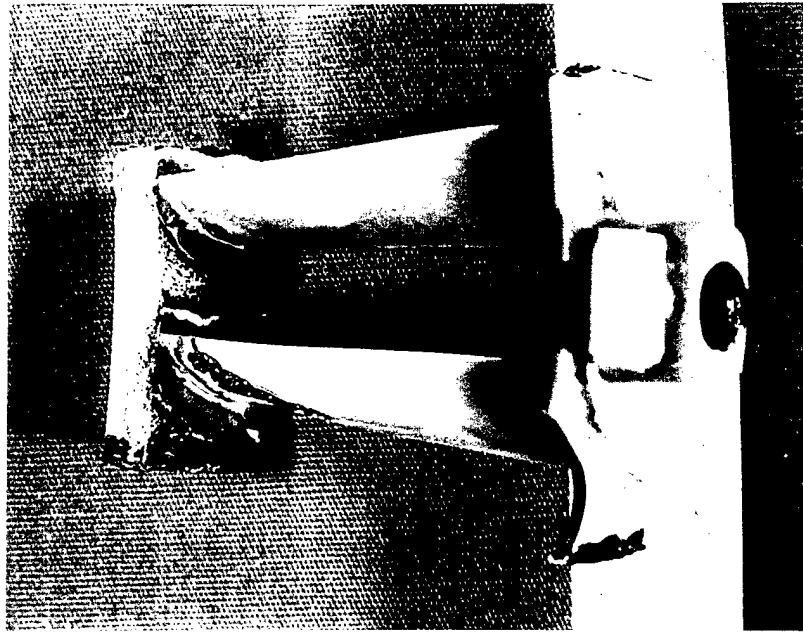
Figures 42–44 depict the 2.33% dipped old stator after 200 hr of salt fog exposure per ASTM-B-117. Some slight corrosion was evident along the braze and inner shroud. However, this section appeared to completely inhibit the white cadmium oxide product from forming and looked the best in comparison to the other sections.

Figure 42. 2.33% Dipped Stator After 200 hr Salt Fog Exposure, Concave Side (Magnified 1.5 \times).

Figure 43. 2.33% Dipped Stator After 200 hr Salt Fog Exposure, Convex Side (Magnified 1.5 \times).

Figure 44. 2.33% Dipped Stator After 200 hr Salt Fog Exposure, Braze Area (Magnified 1.5 \times).

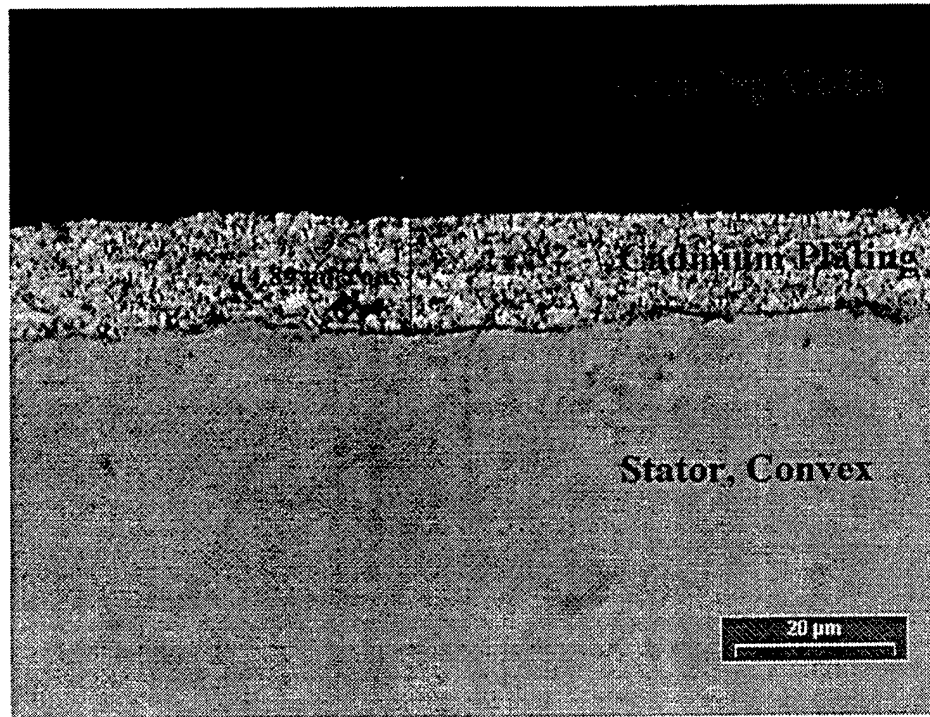
5.4 Coating Thickness. Cross sections of several vanes were prepared metallographically and examined per ASTM-B-487. Figure 64 shows a representative area along the convex side of a vane near the middle where the cadmium plating was approximately 0.00054 in thick. In contrast, Figure 65 is indicative of the cadmium plating observed on much of the concave side of a vane near the middle where the thickness was approximately 0.00043 in.

Figure 64. Cadmium Thickness, Middle of Vane, Convex Side.

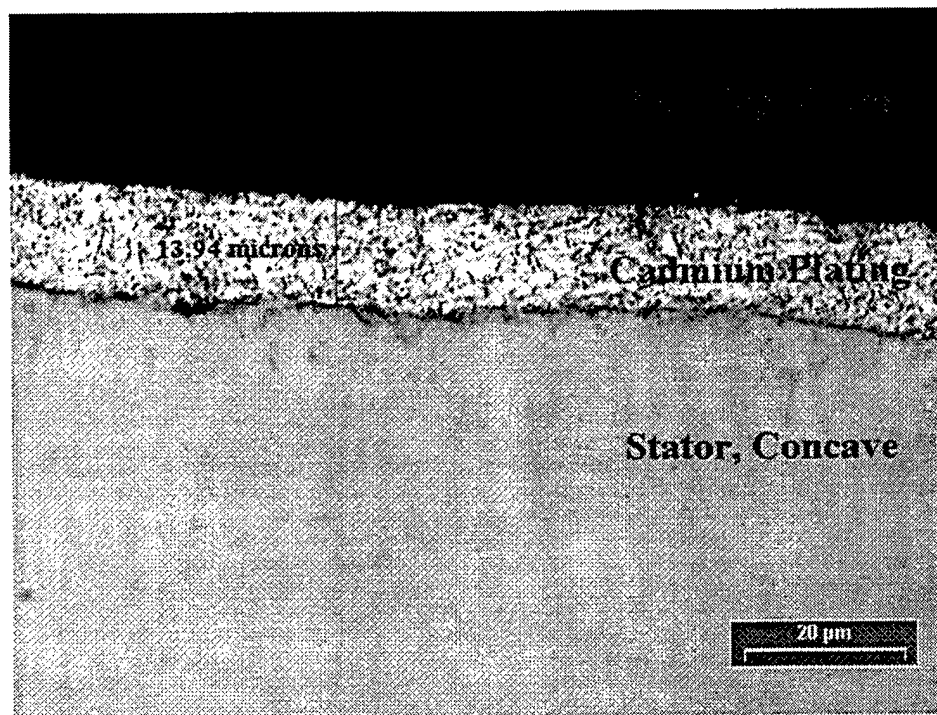
Figure 65. Cadmium Thickness, Middle of Vane, Concave Side.

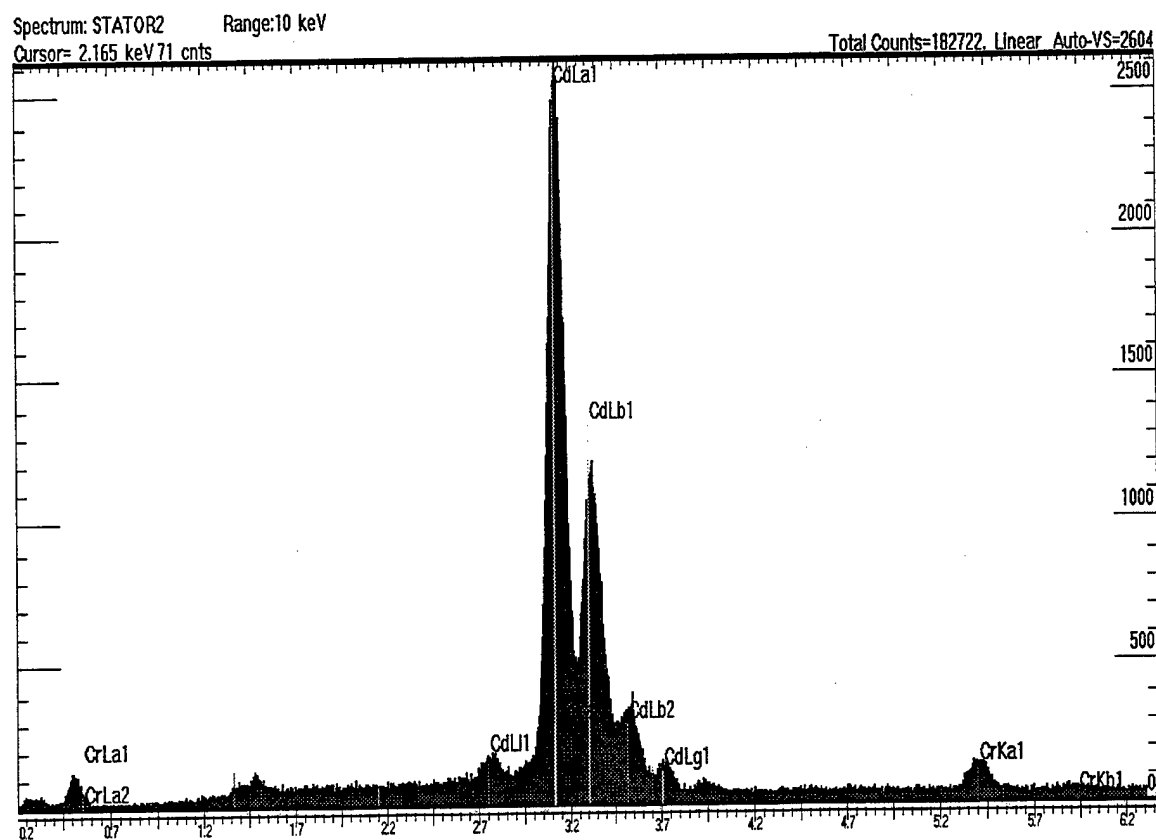
5.5 SEM/EDS Examination. Portions of the sectioned components were examined by SEM. A cadmium plating was detectable on all surfaces. Verification of the existence of a chromate or chromic acid sealer over the cadmium coating was performed with the EDS system. This was evidenced by the presence of the element chromium (Cr) within the EDS spectrum. Figure 66 depicts the EDS spectrum from the new stator vane section.

Figure 66. EDS Spectrum Indicating the Presence of Chromium.
